## ACCIDENT REPORT ANALYSIS

By Norman Ugolini, Civil Engineer, E.I.T.

The accident occurred on 14 April 2012 at approximate 7:50 PM on the bypass to Goose Creek, SC at the Ashley Phosphate on ramp to the bypass involving 3 cars.

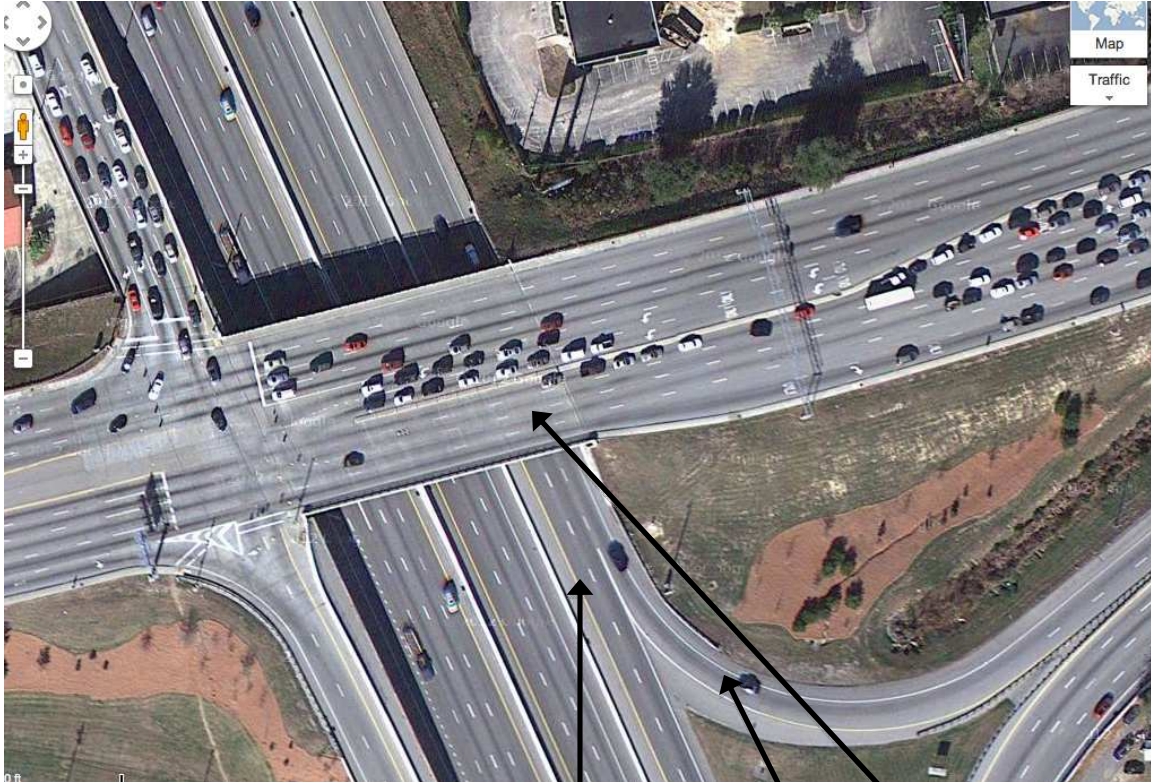
Car 1 driven by Amanda Koster  
Car 2 driven by Norman Ugolini  
Car 3 driven by Tomas Jennings

Car 2 and 3 are traveling on the left most lane high speed lane  
Car 1 entered the highway on the ramp  
Accident site under the bridge

After leaving the curve of the entry ramp, car 1 immediately proceeds across 2 lanes of traffic (not utilizing the merge lane) to the left high speed lane into the path of car 1 and 2. Two seconds later the accident occurred the bridge.

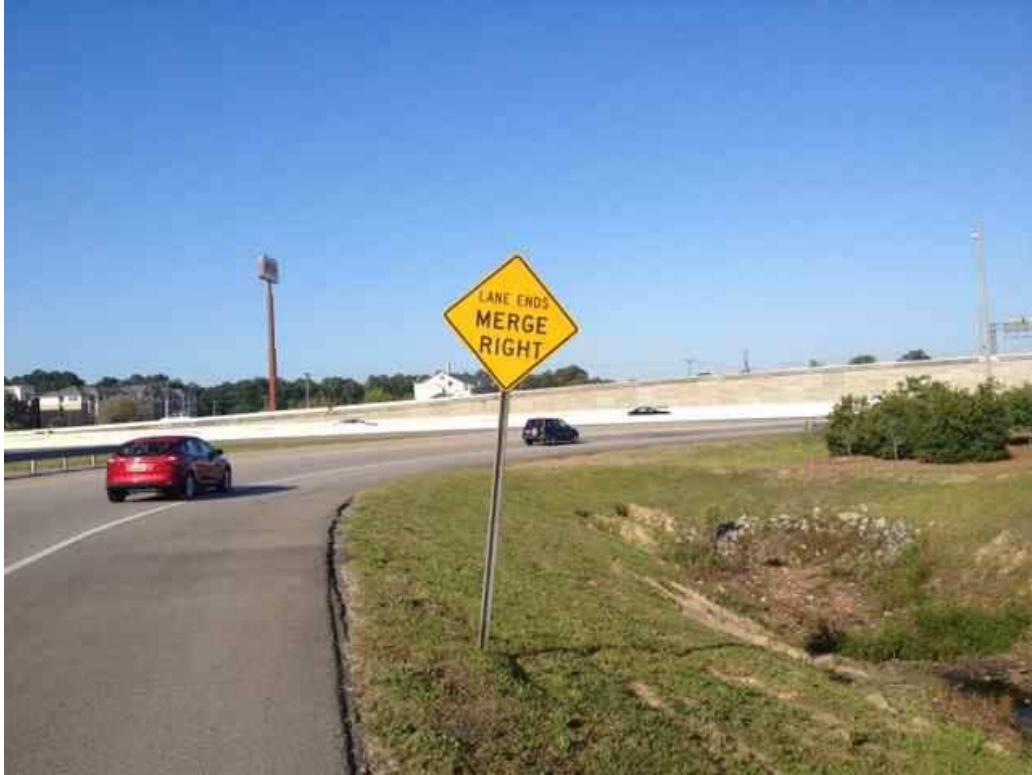
Photo 1: Ramp, just prior to entry onto the interstate ramp.

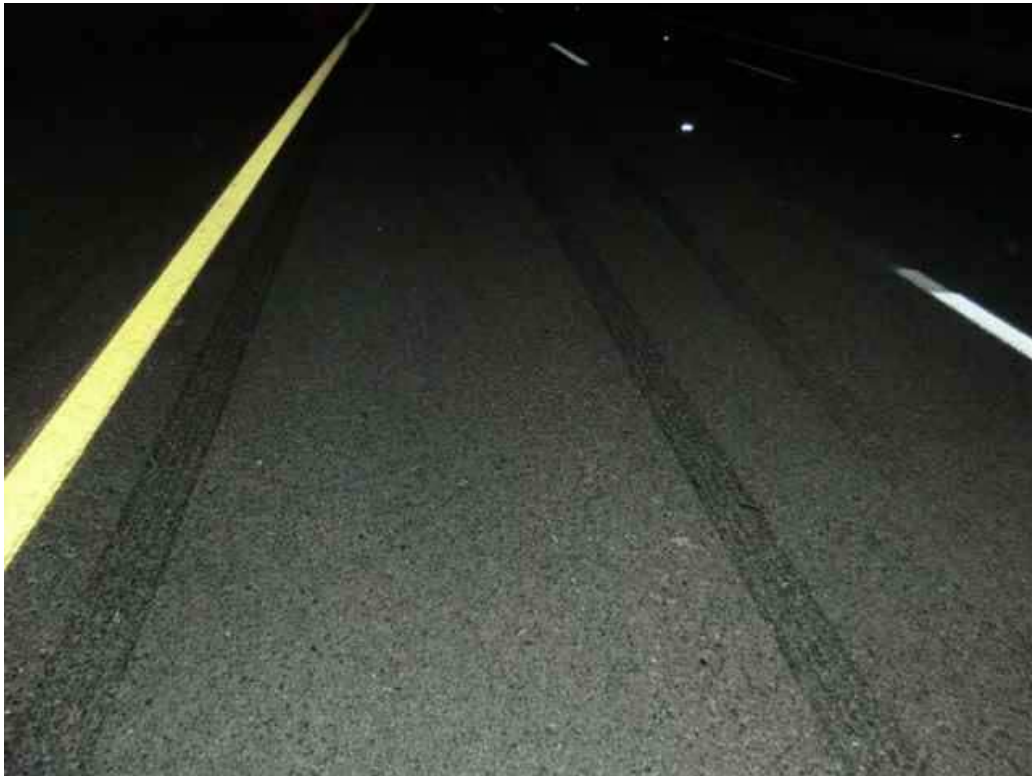
Photo: Just after officer left scene of accident indicating 2 sets of skit marks.

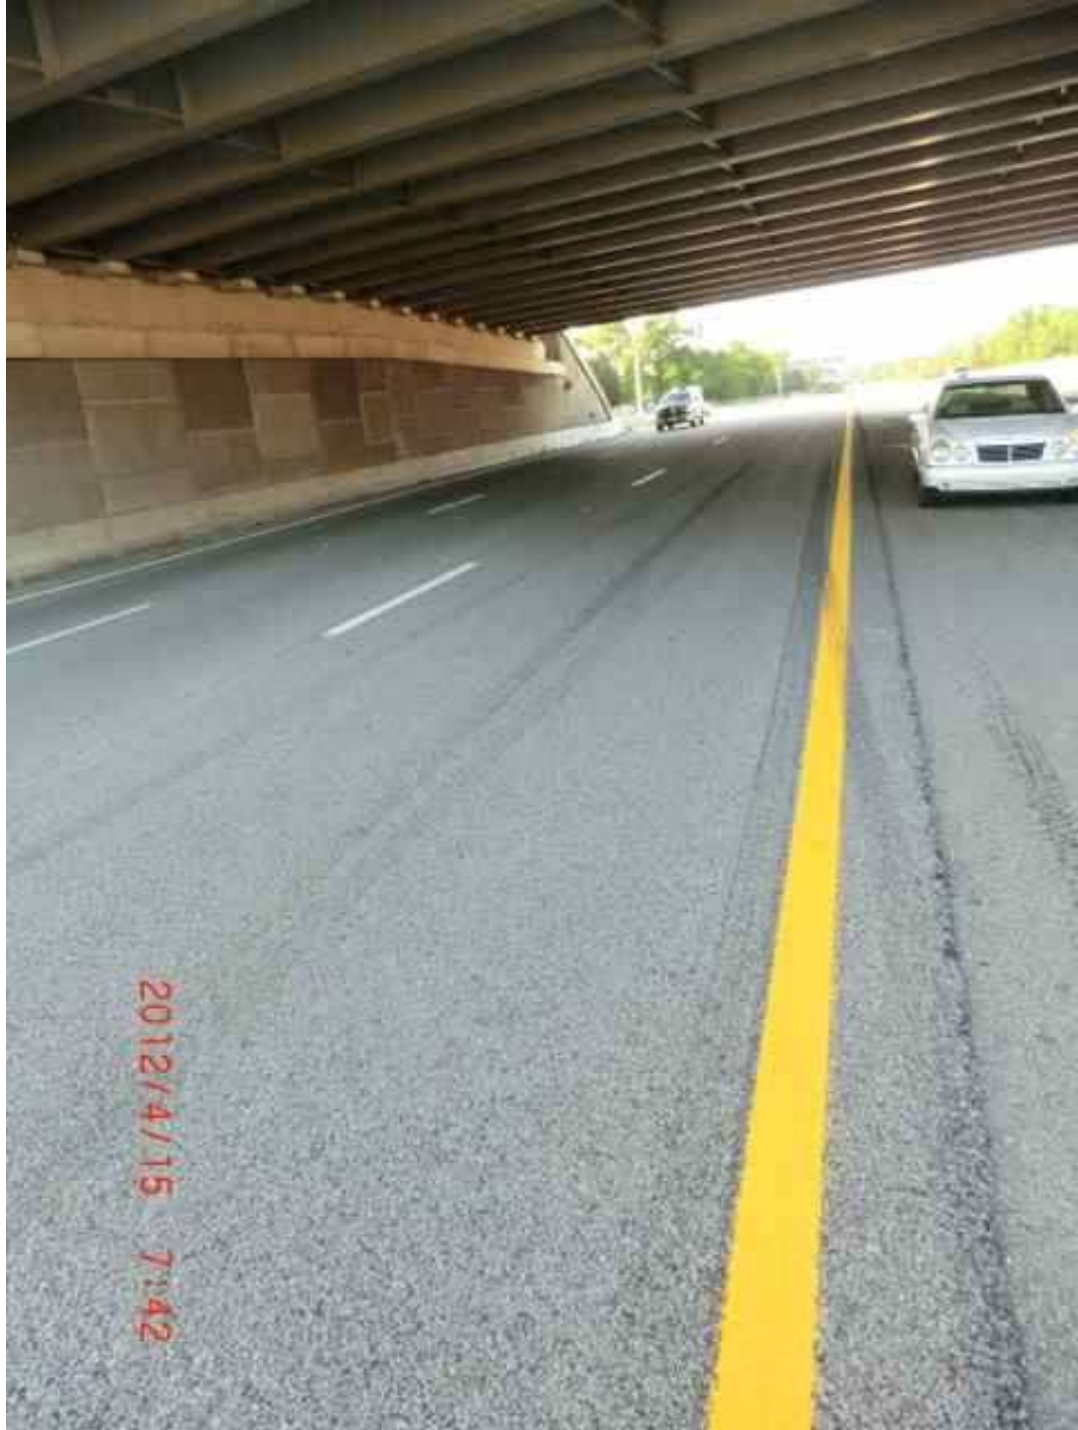
Photo: Start of accident skid marks. Note two sets of skids and position under the bridge ~190 ft from on ramp (where the truck is entering the highway).

The distance from the end of the on ramp to the point of impact is approx. 190 ft.

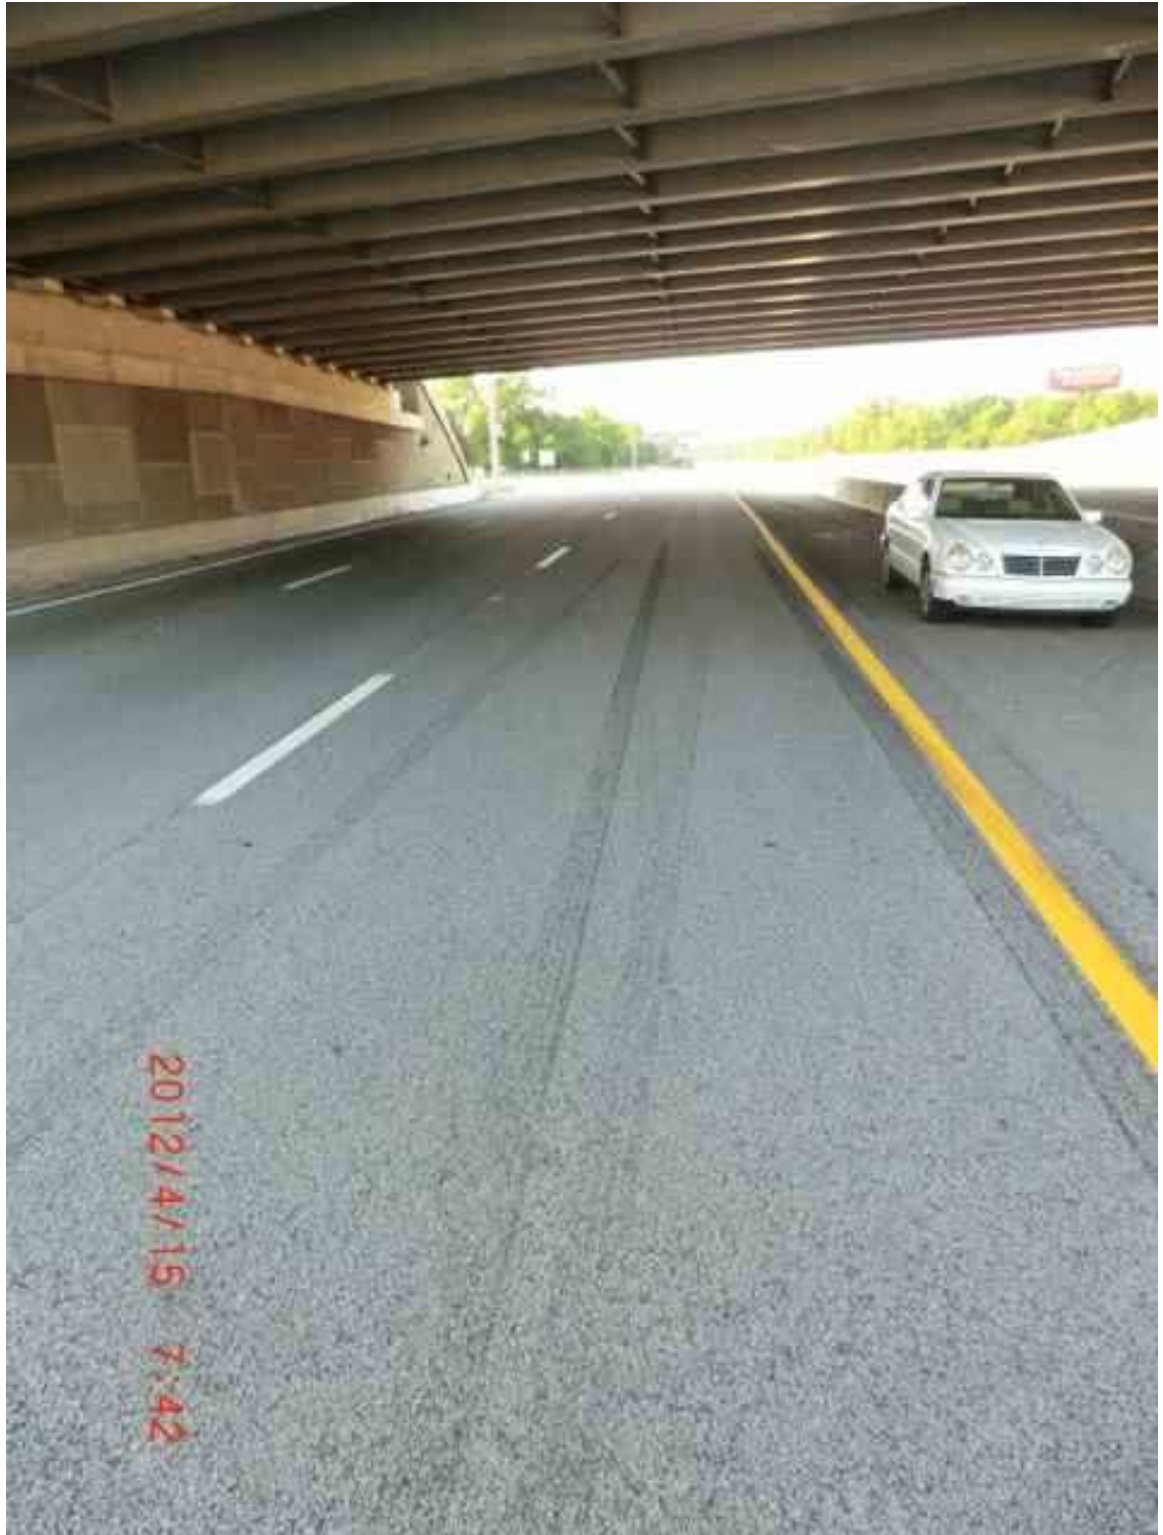
Photo: Start of skid. Clearly shows both car 1 and 2 were skidding at time of impact.

8 ft. of separation between skids, indicates both drivers had their foots on the brake at time of impact. Human reaction time is 1 to 2 sections. If a driver has the foot on the accelerator then 1 second of reaction time at 50 mph equates to 73 ft. of travel distance. At 40 mph, 1 sec reaction time equates to 56 ft. Since there is only 8 ft. of separation, the spacing of the beginning of the skid could only have occurred if both drivers were braking almost simultaneously.

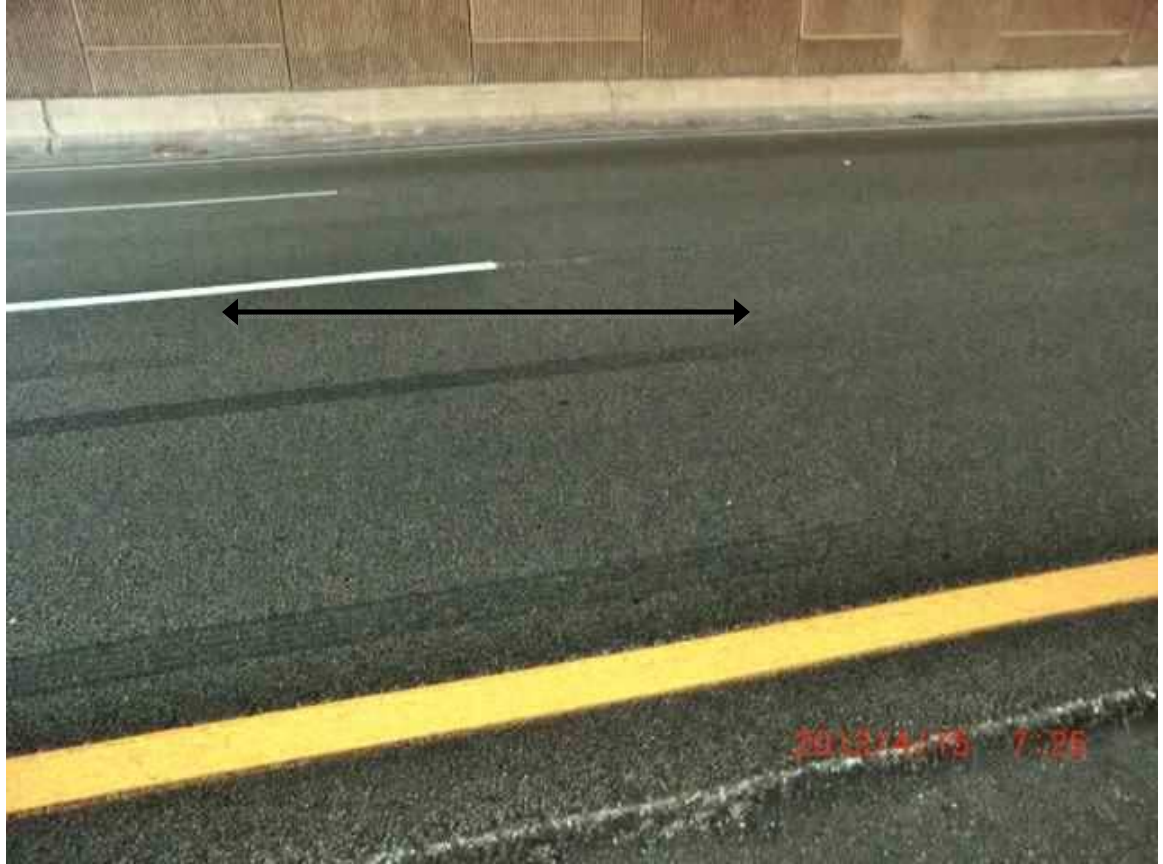
Beginning of skid. Note the distance between the first and second set of skids measured at 8 ft.

There is 8 ft. of separation between the skids of car 1 and 2.

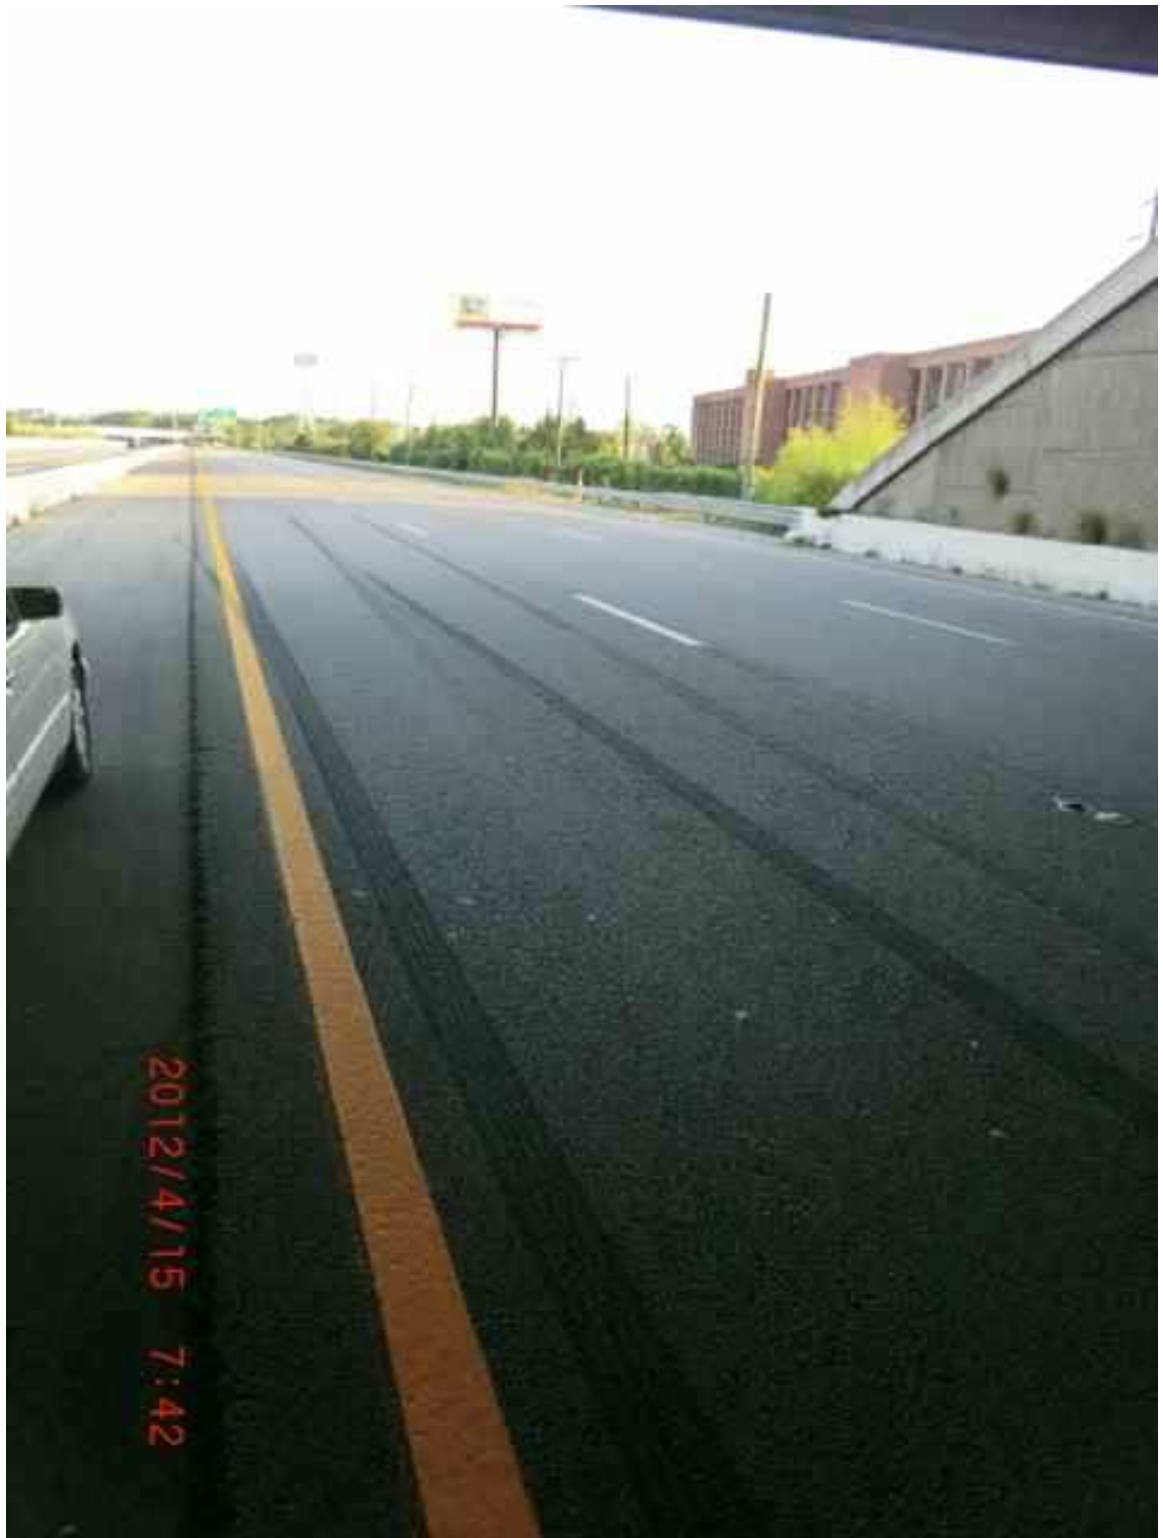
Note: Two skid marks on left is from car 2, the two skid marks on right is from car 1 which extend beyond car 2's marks.

Measured distance indicates car 1 skidded for a measured distance of 91 ft and car 2 skidded for measured distance of 72 ft with 8 ft of separation between the two sets of skid marks. Adding 91 ft plus the 8 ft separation at the beginning of the skid (total of 99 ft) would account for the investigating officers estimate of approximately 105 ft of skid.

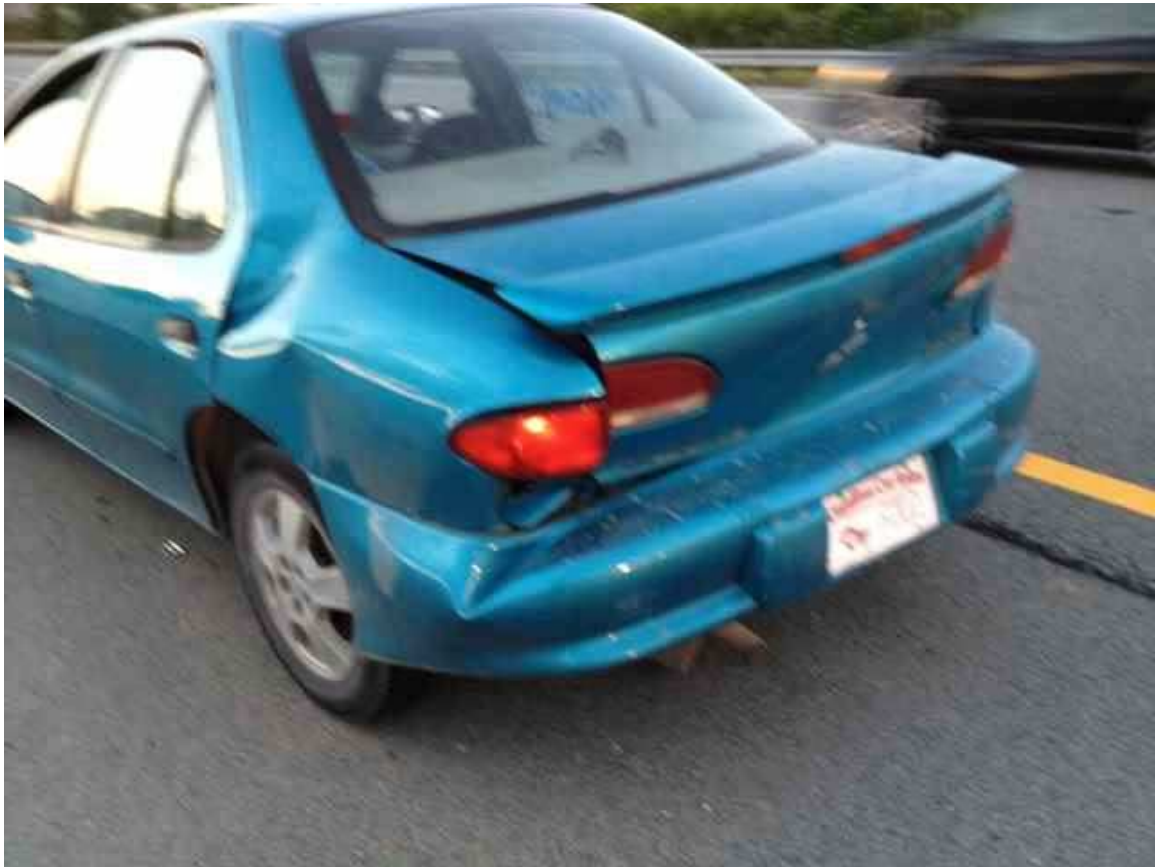
Damage to car 1 confined to left rear

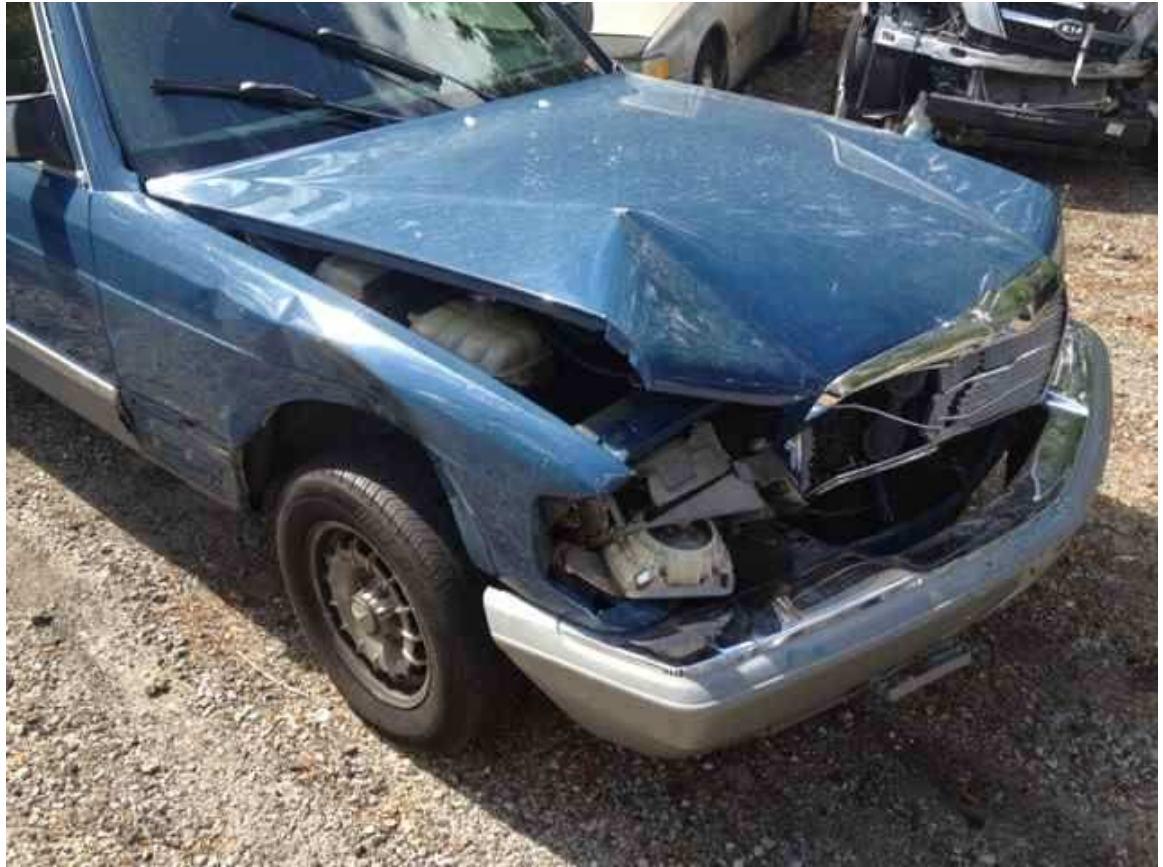
At the time of the accident, car 2 was ONLY damaged on the right side of the hood and the right quarter panel after being hit by two cars.

Damage to car 2 confined to the right front of car. No other damage occurred.

It is important to note that the skid of car 2 was due to the back tires. Vehicular weight during a hard stop transfers to the front of the vehicle unloading the back of the car causing a rear wheel skid.

When car 1 and 2 collided, the force of the collision on the right front of car 2, created a coupled moment around the center of mass of car 2. The force on the right front combined with the unloaded locked rear tires, caused a rotation the back end of car 2 toward retaining wall (skid marks). The rotation exposed the passenger side of the car. Rotation was significant enough that only right front fender of the car 2 was damaged, leaving the entire right side of the car 2 untouched.

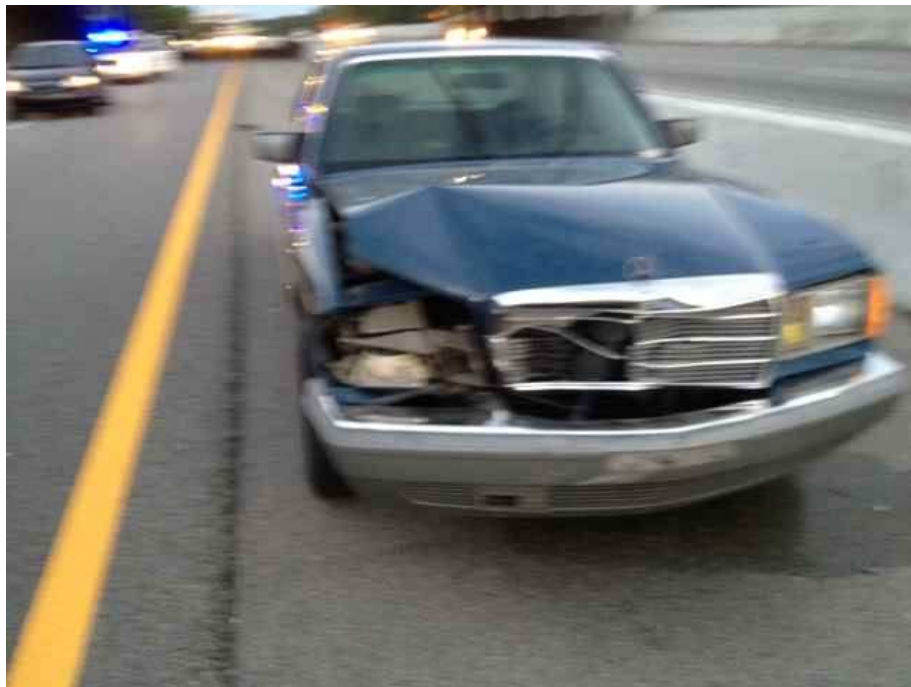
At scene, at time of accident. Dusk lighting at approximately 8 pm.

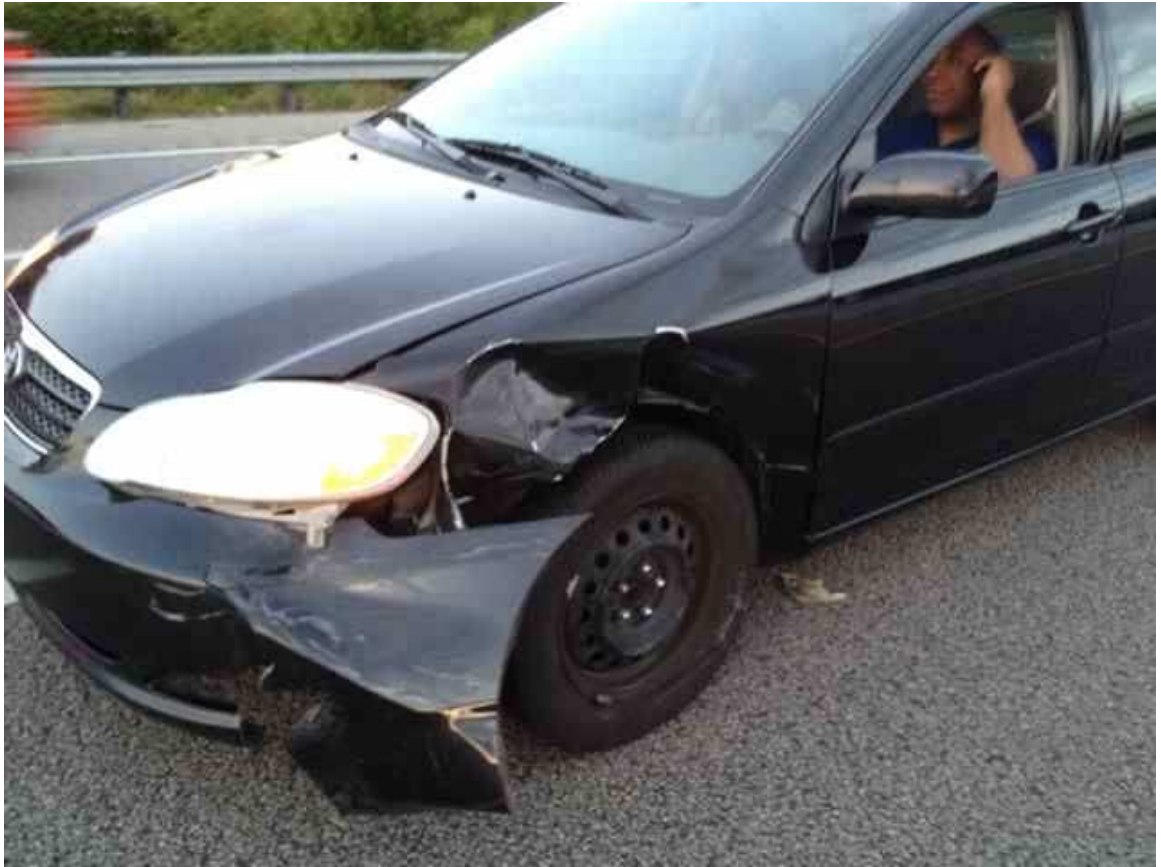
Car 3 was only lightly damaged on the left front fender and was able to drive away from the scene of the accident after hitting car 2.

Damage to car 3 confined to left front quarter panel and bumper. No other damage occurred.

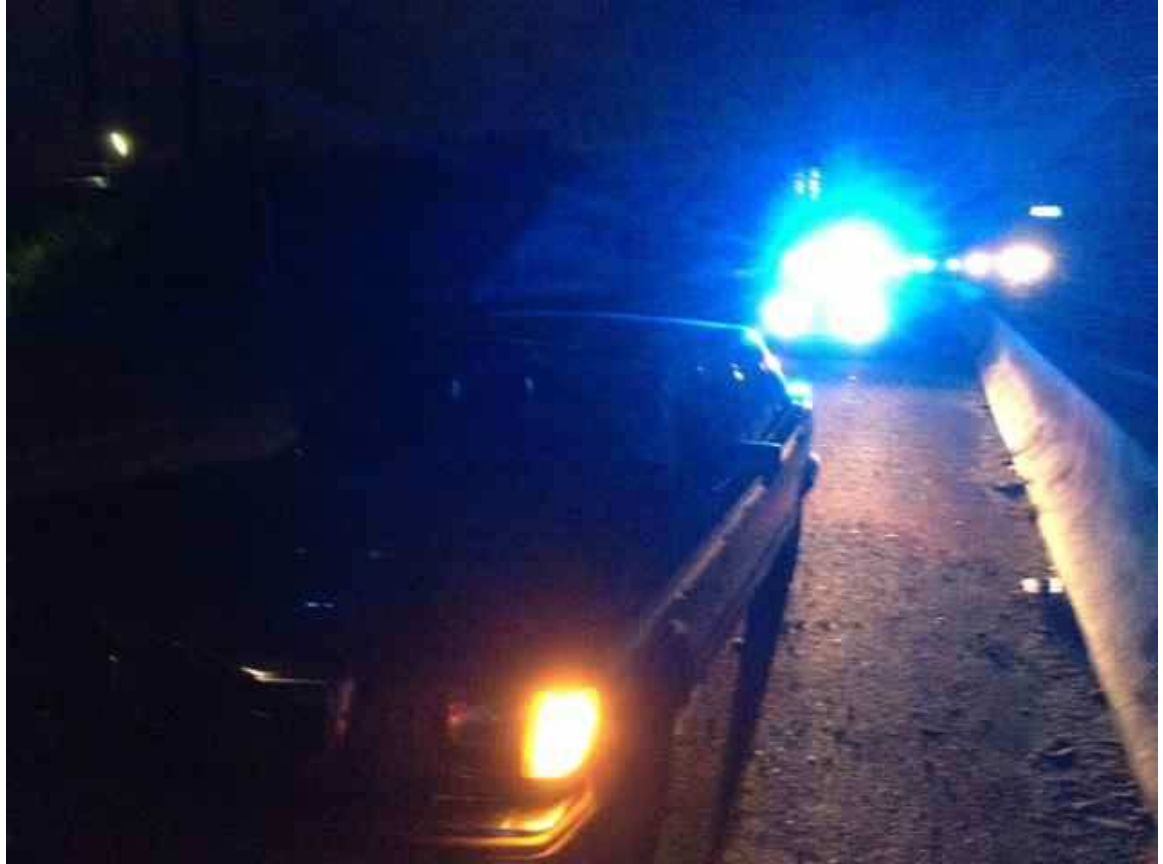
Site conditions at time of investigation by highway patrol. Approximately 9 to 9:30 pm.

The highway patrol office L/CPL McAbee stated to Driver 2 that he found no evidence of the Car 1 braking and reported that car 2 skidded for a distance of 105 ft. These statements are incorrect and could possibly be due to the investigation taking place at night on an unlighted highway with the danger of high-speed traffic impeding the data gathering.
